EVALUATION OF DOW CHEMICAL PRODUCTION EXTRUDED TRUSS-WEB LANDING MAT

D. W. White, Jr.

March 1974

Conducted by U. S. Army Engineer Waterways Experiment Station
Soils and Pavements Laboratory
Vicksburg, Mississippi

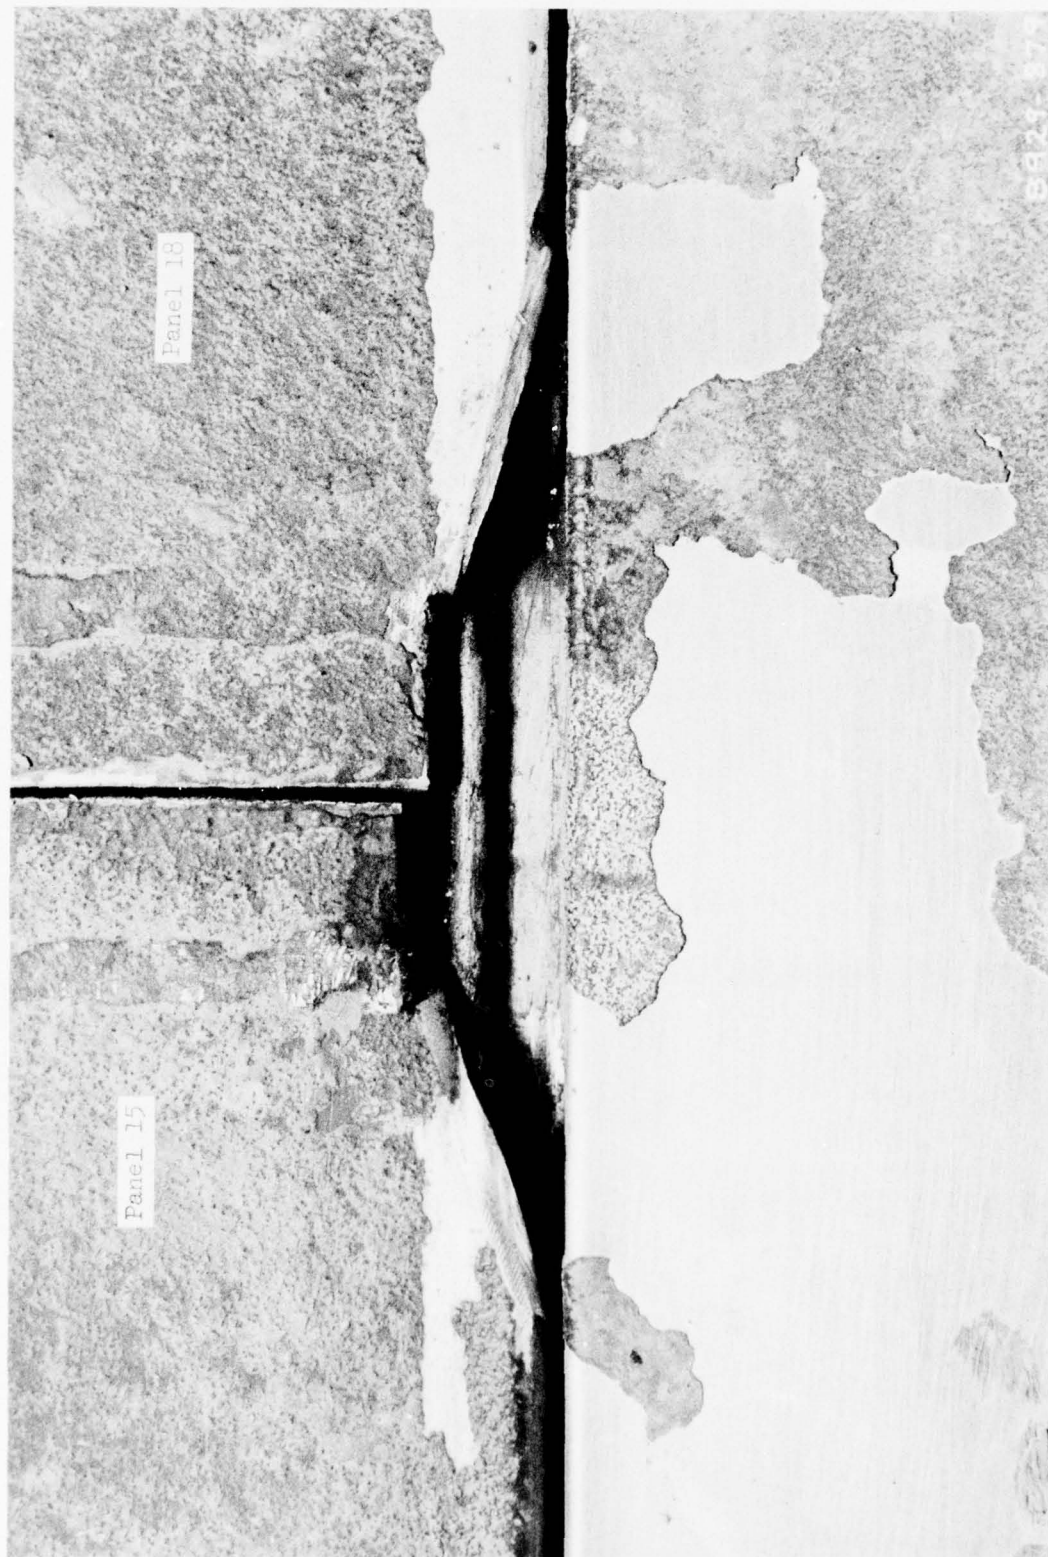
Panels 15 and 18 after 804 coverages of channelized traffic

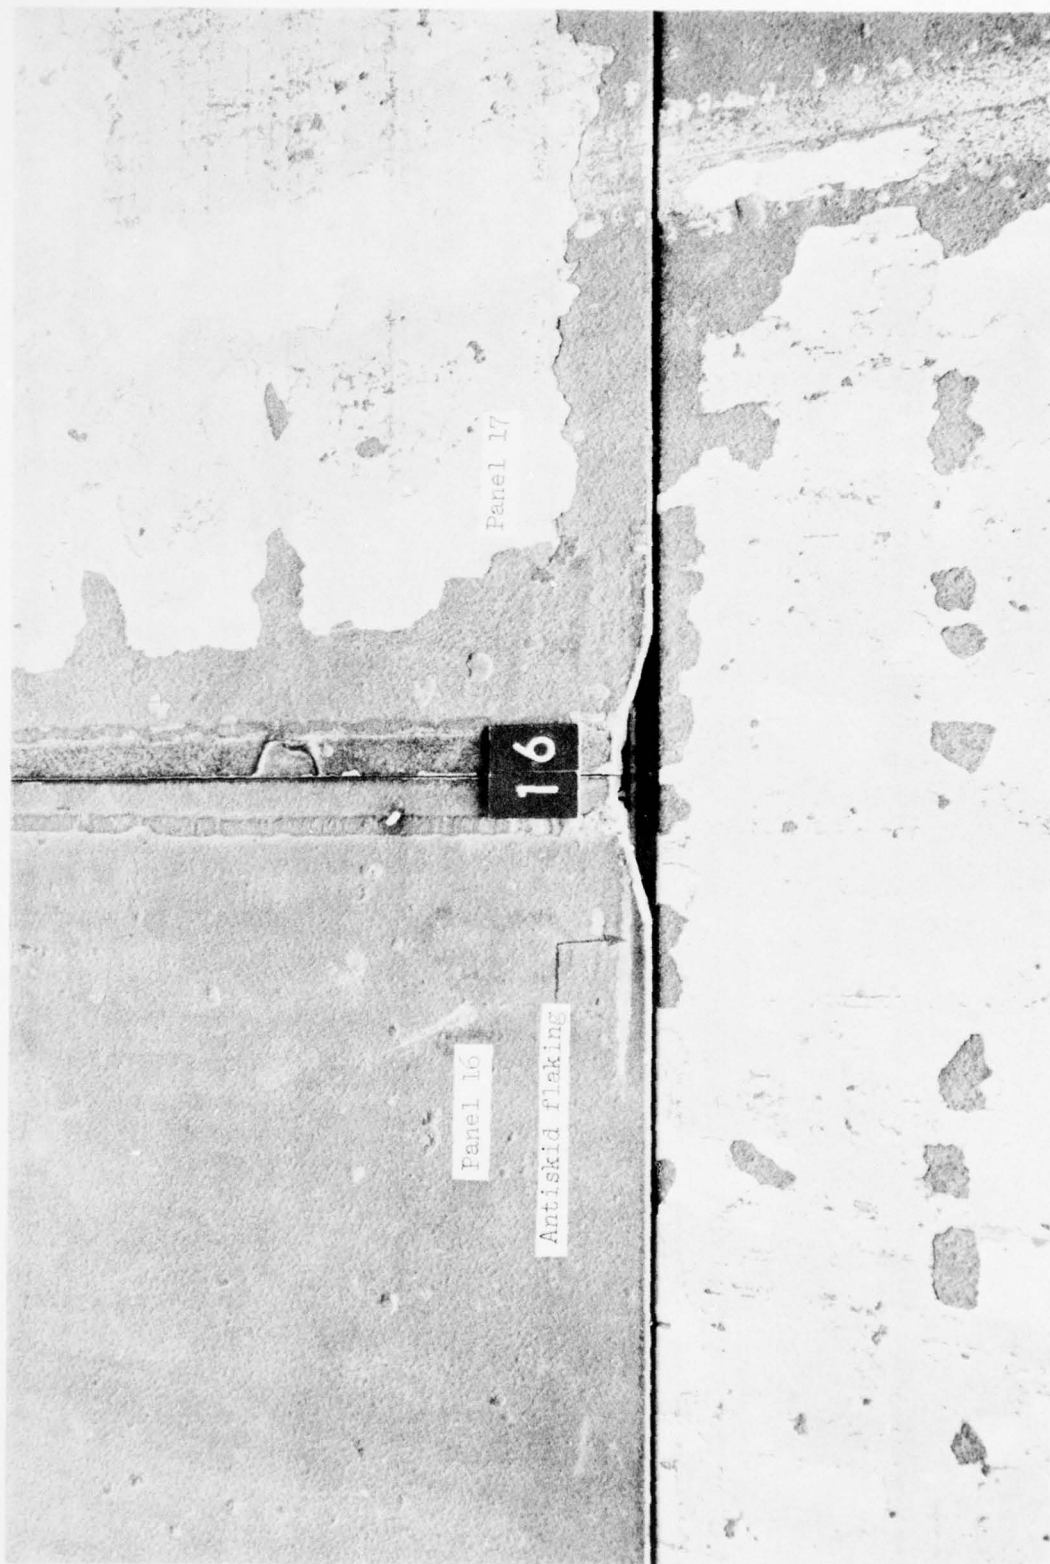
Panels 16 and 17 after 500 coverages, Phase 1

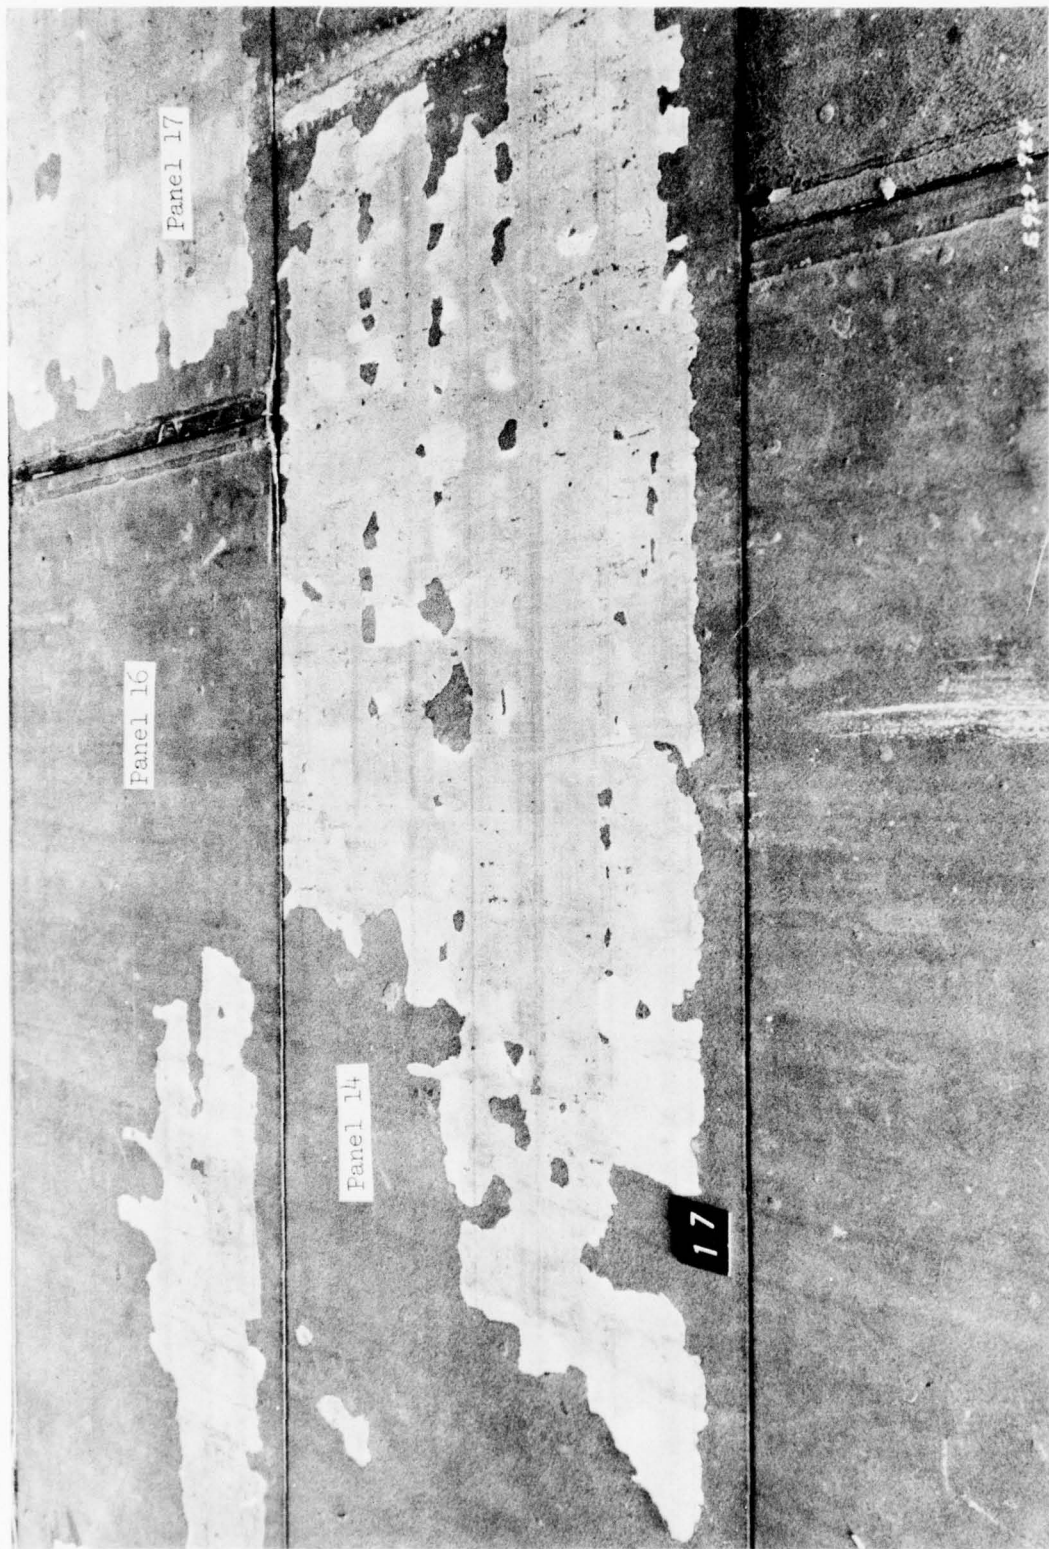
Bare areas on panels 14, 16, and 17 where antiskid had come off after 500 coverages, Phase 1

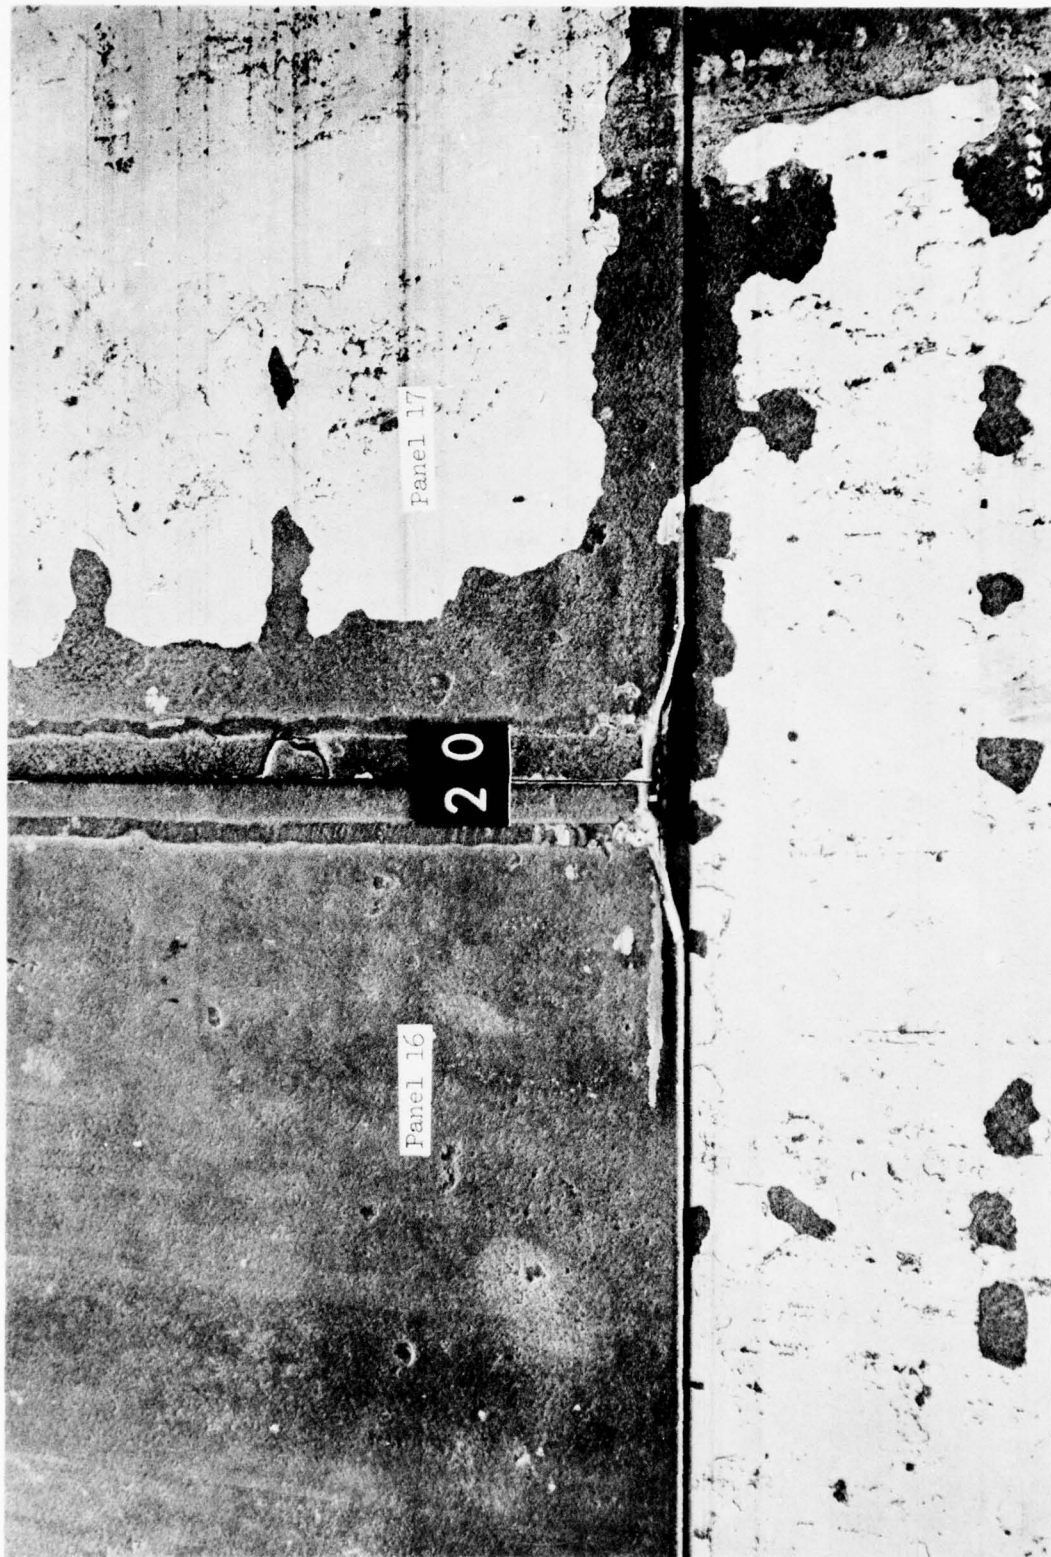
Panels 16 and 17 after 760 coverages, Phase 1

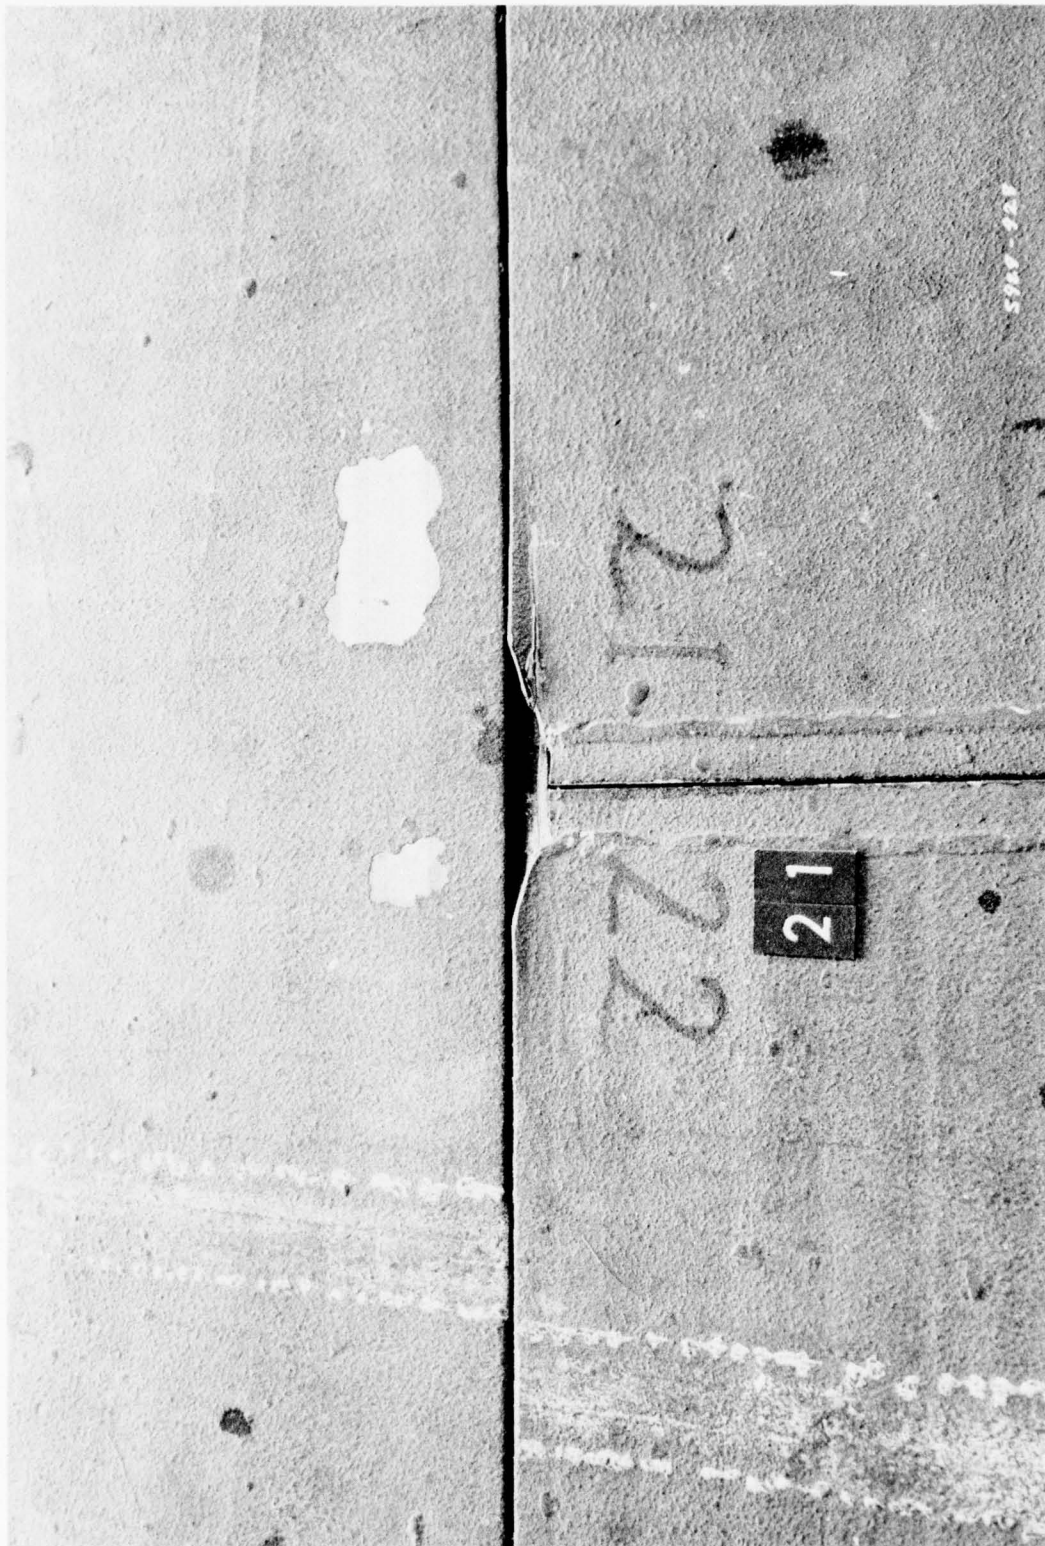
Split in female connector of panel 21 after 760 coverages, Phase 1

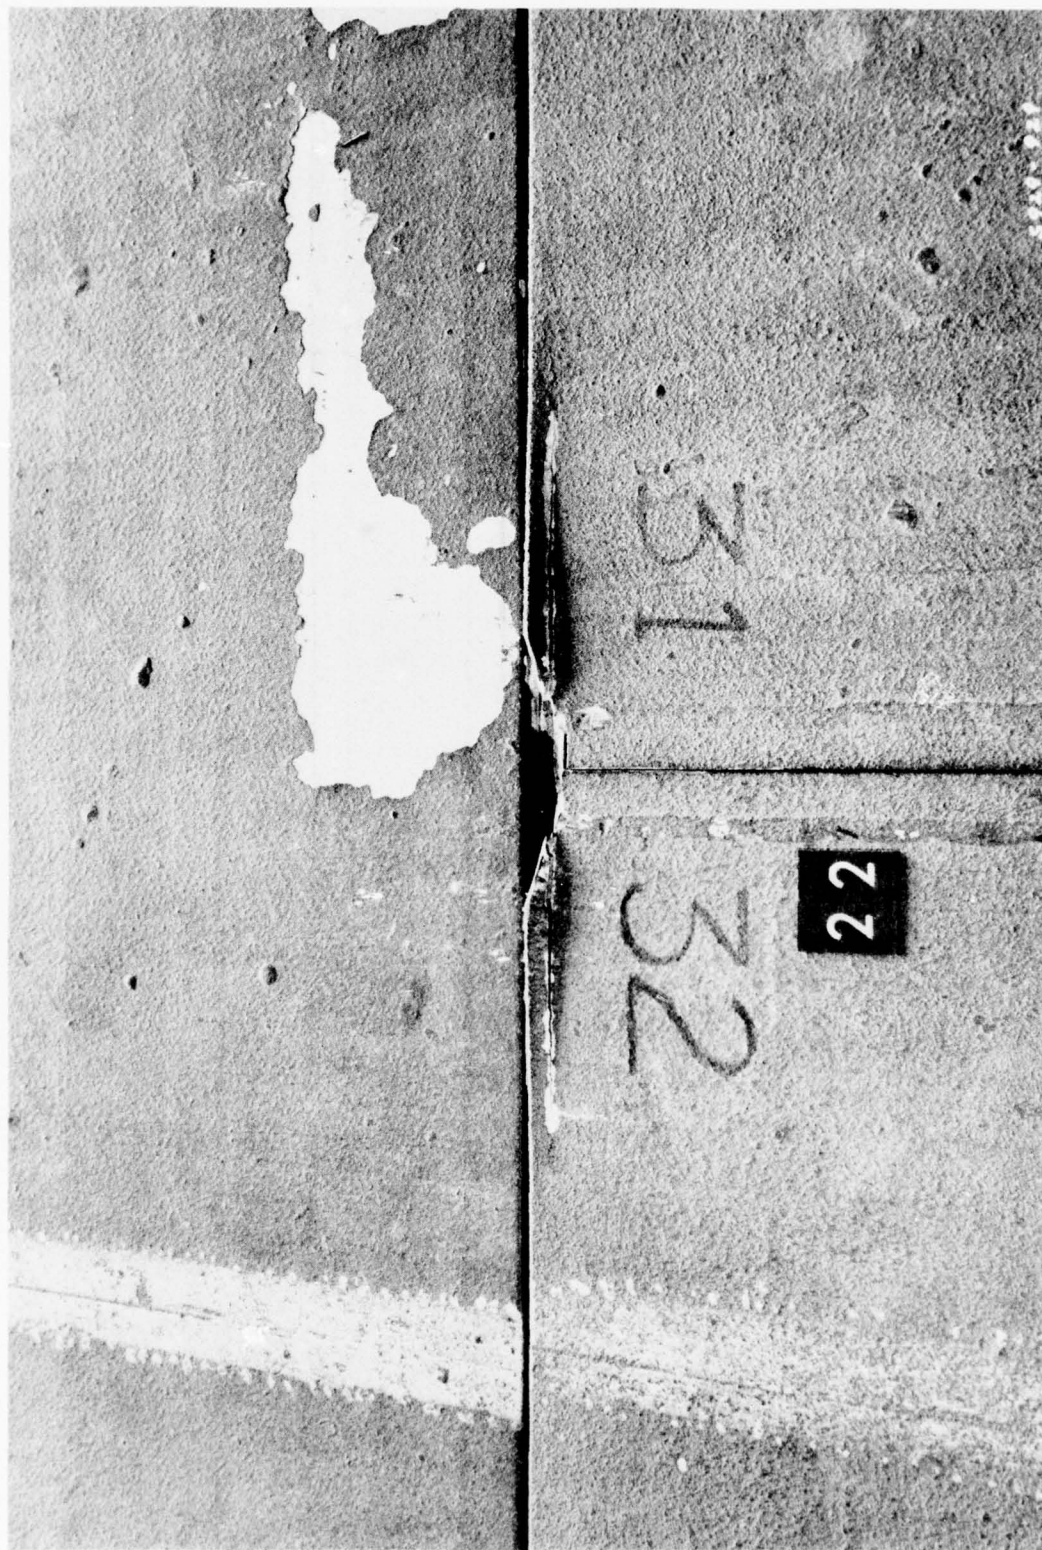
b. Standard traffic pattern, Phase 1. The mat sustained 1040 coverages of the 50,000-lb SWL with a 250-psi tire-inflation pressure on a 4-CBR subgrade with only two panel failures (panels 31 and 32) due to tire hazards.

Split in female connector of panels 31 and 32 after 760 coverages, Phase 1

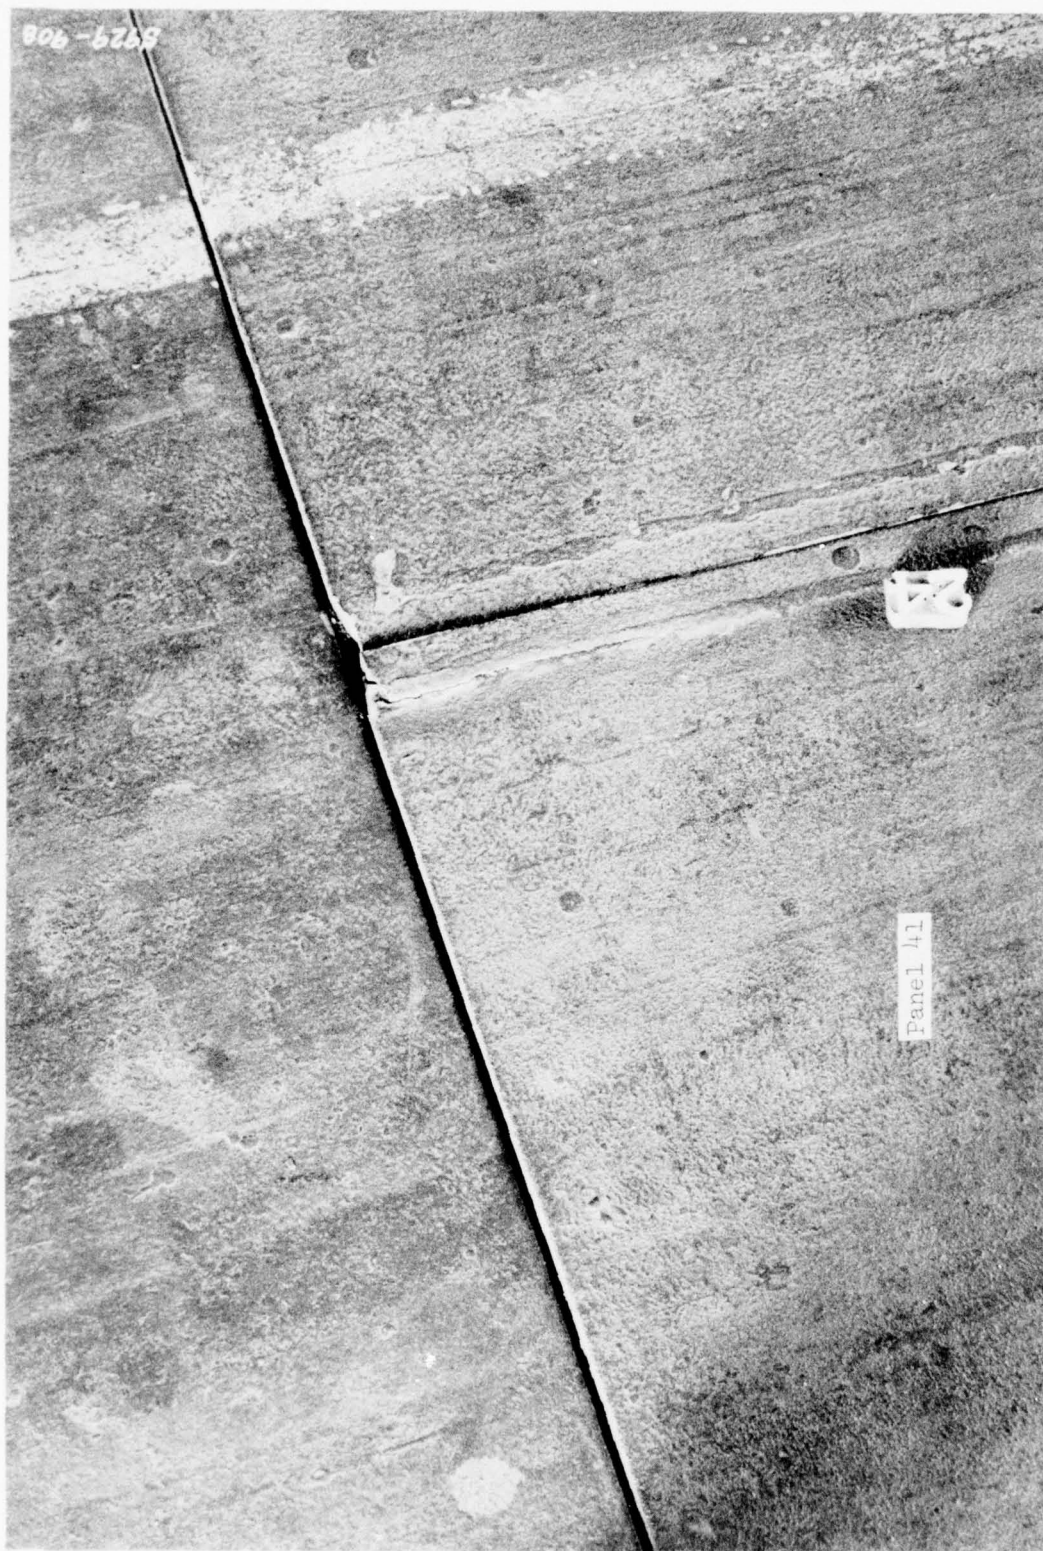
Weld crack at male I-lock corner of panel 41 after 1040 coverages, Phase 1

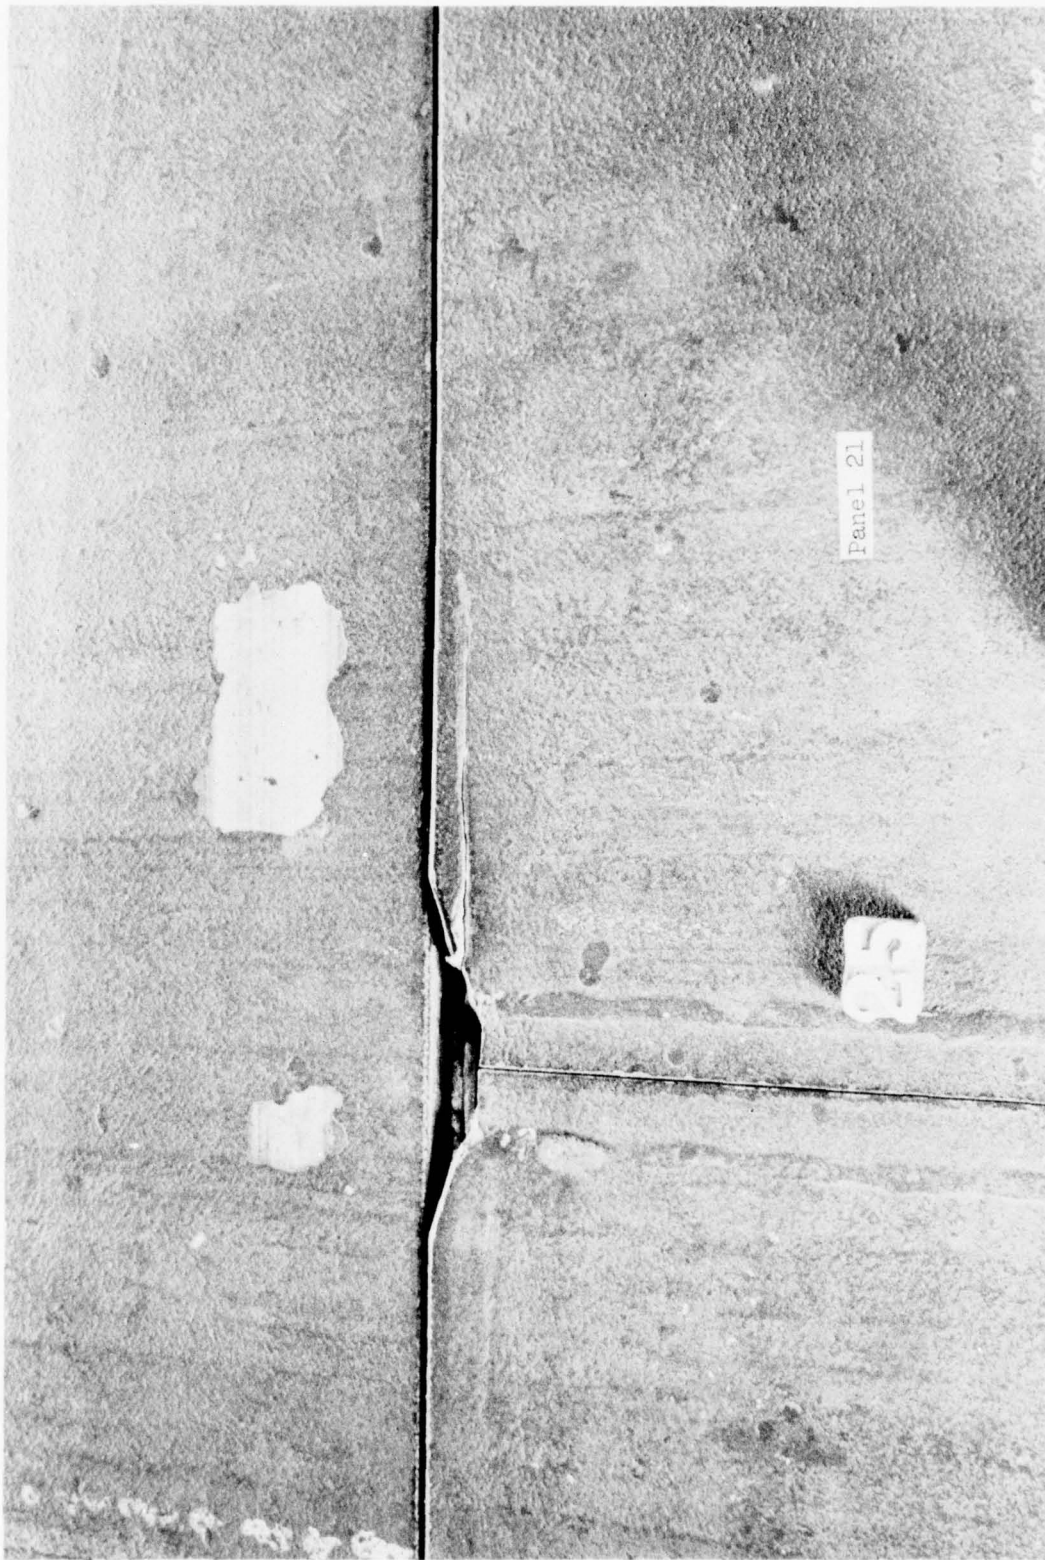
Split in female connector of panel 21 after 1040 coverages, Phase 1

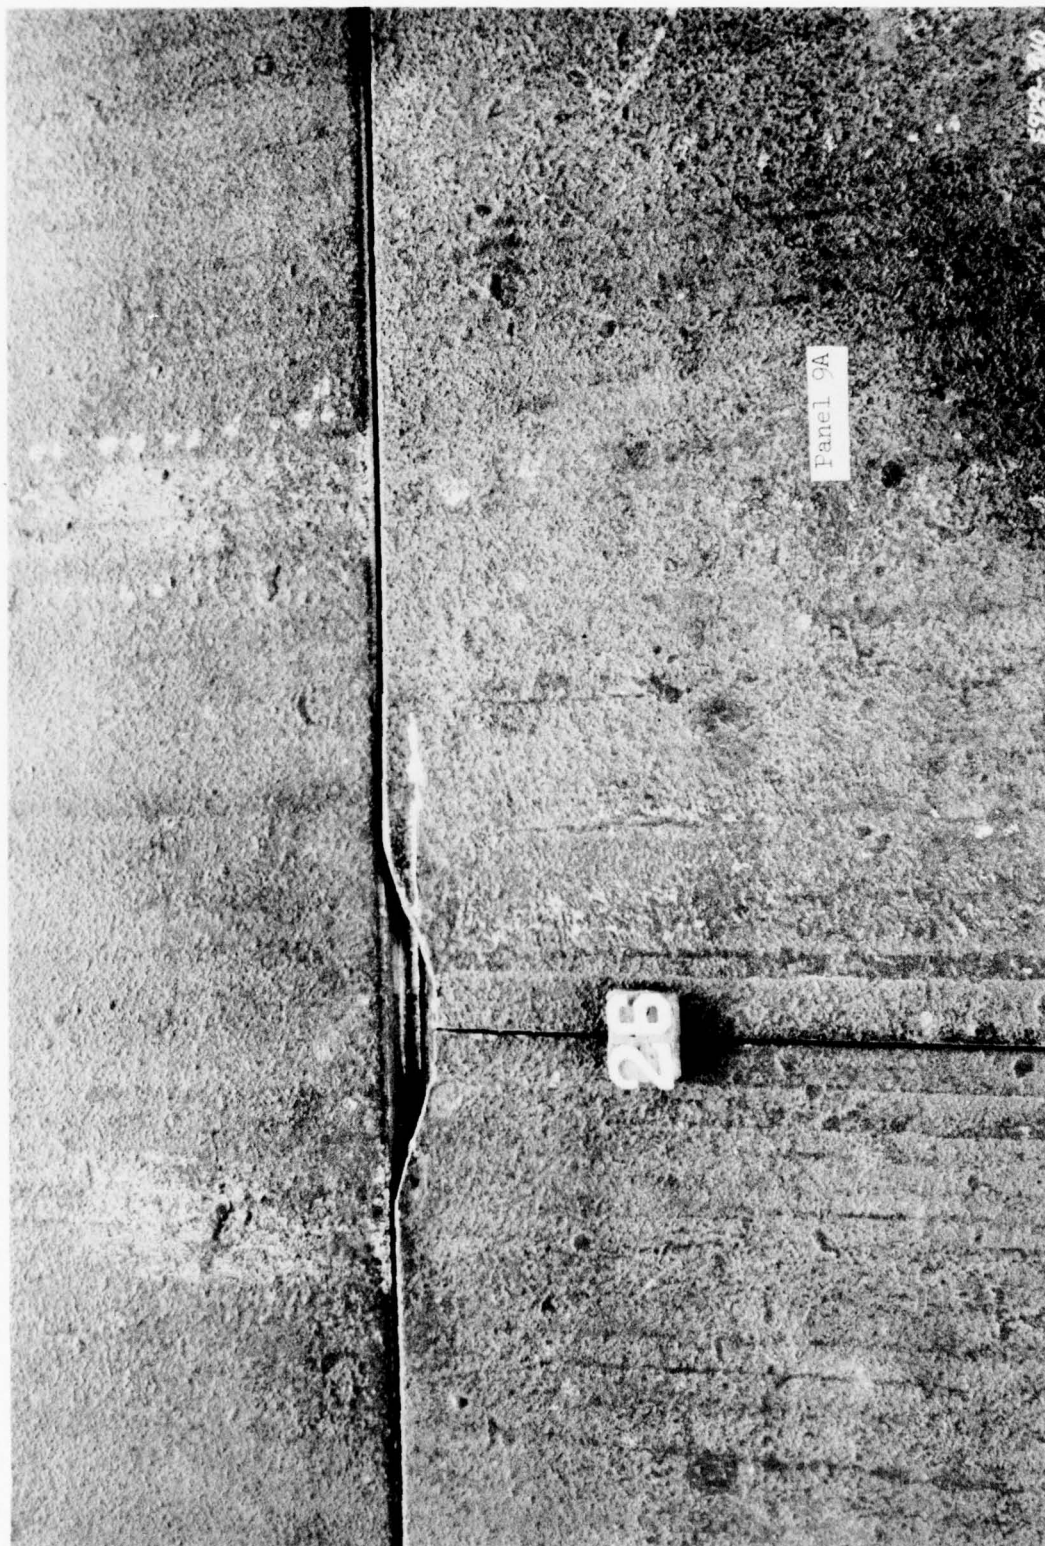
Panel 9A (half panel) after 1040 coverages, Phase 1

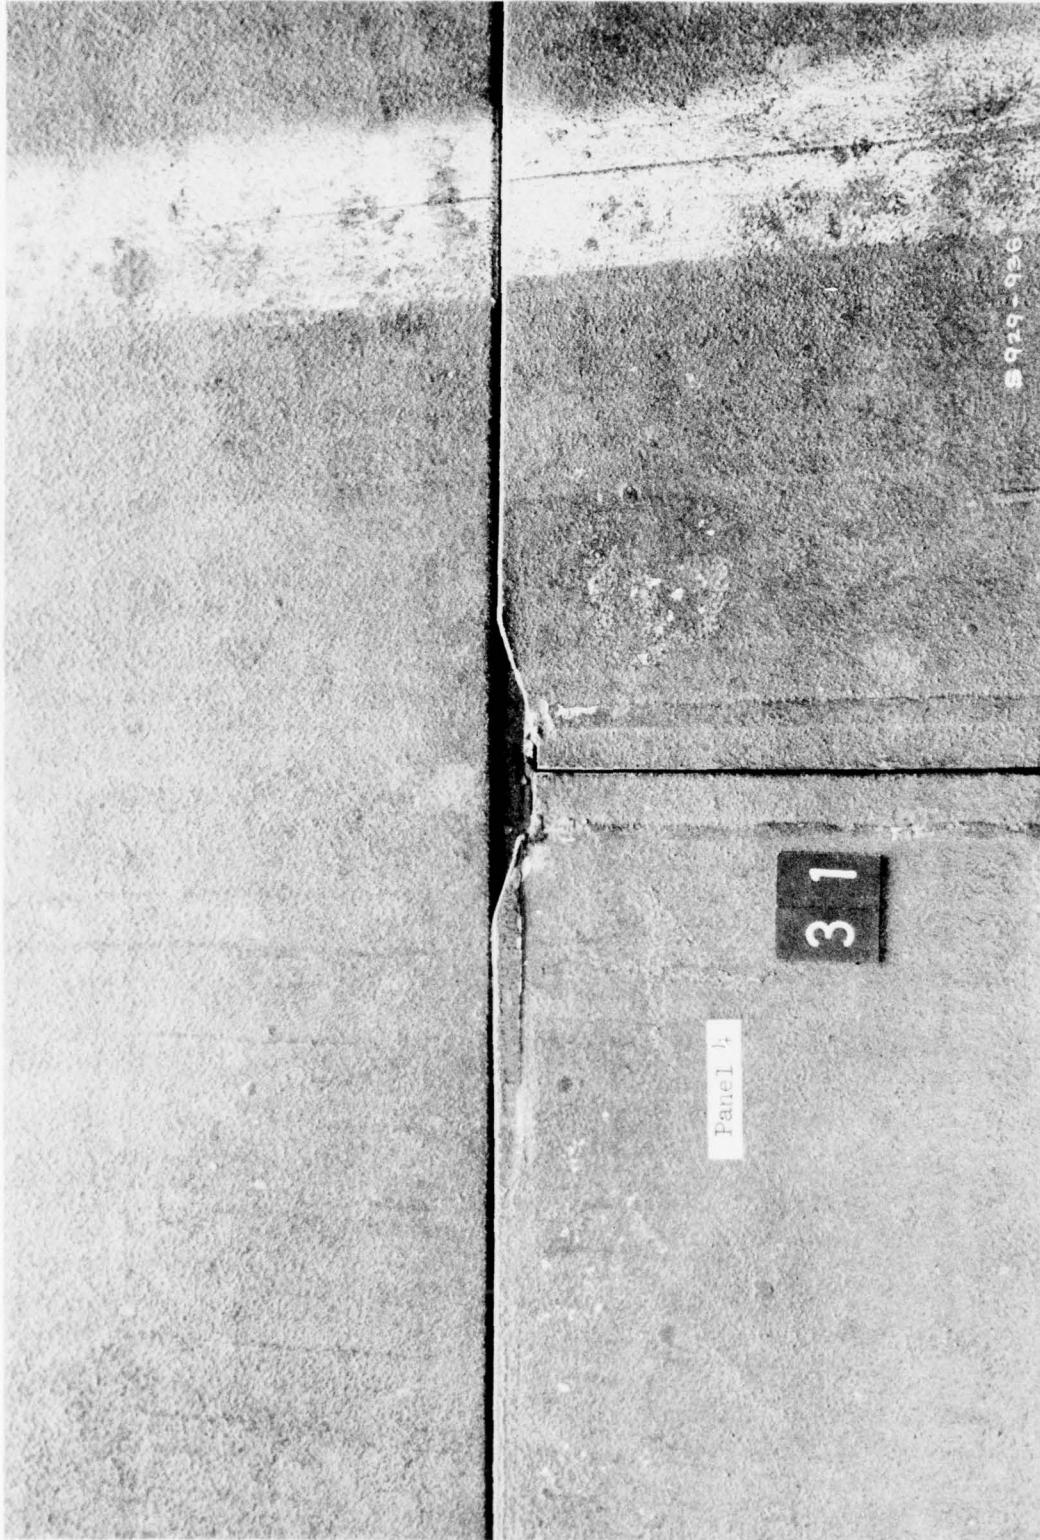
Split in the female connector of panel 4 after 832 coverages, Phase 2

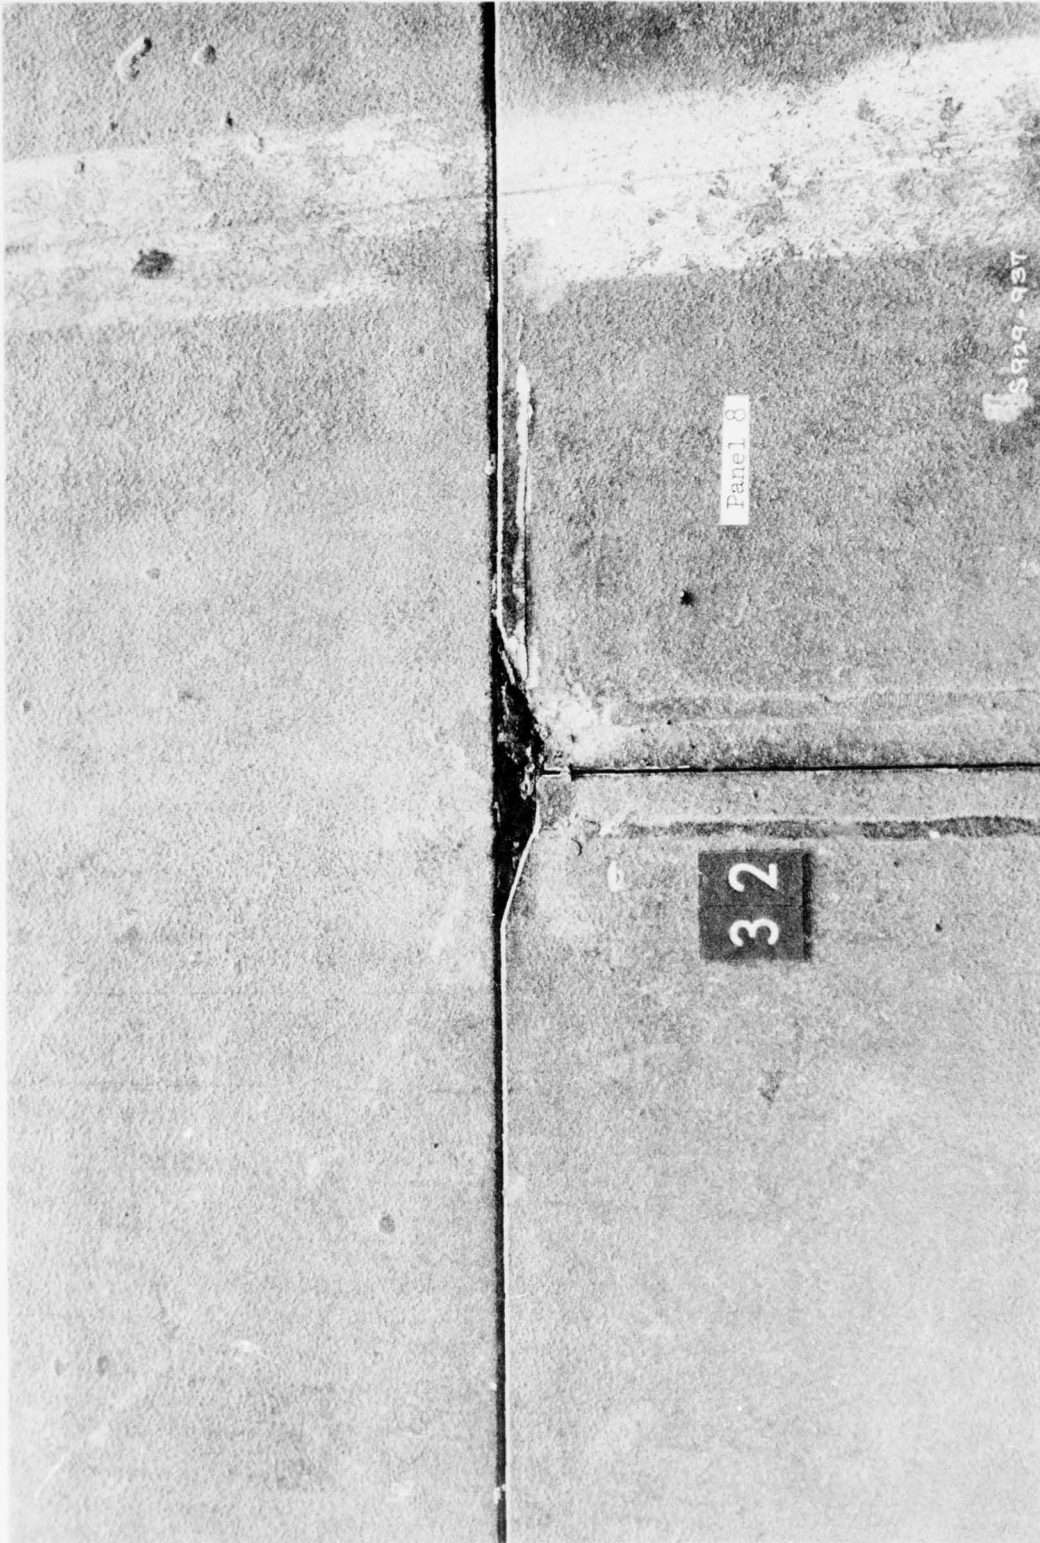
Split in the female connector of panel 8 after 832 coverages, Phase 2

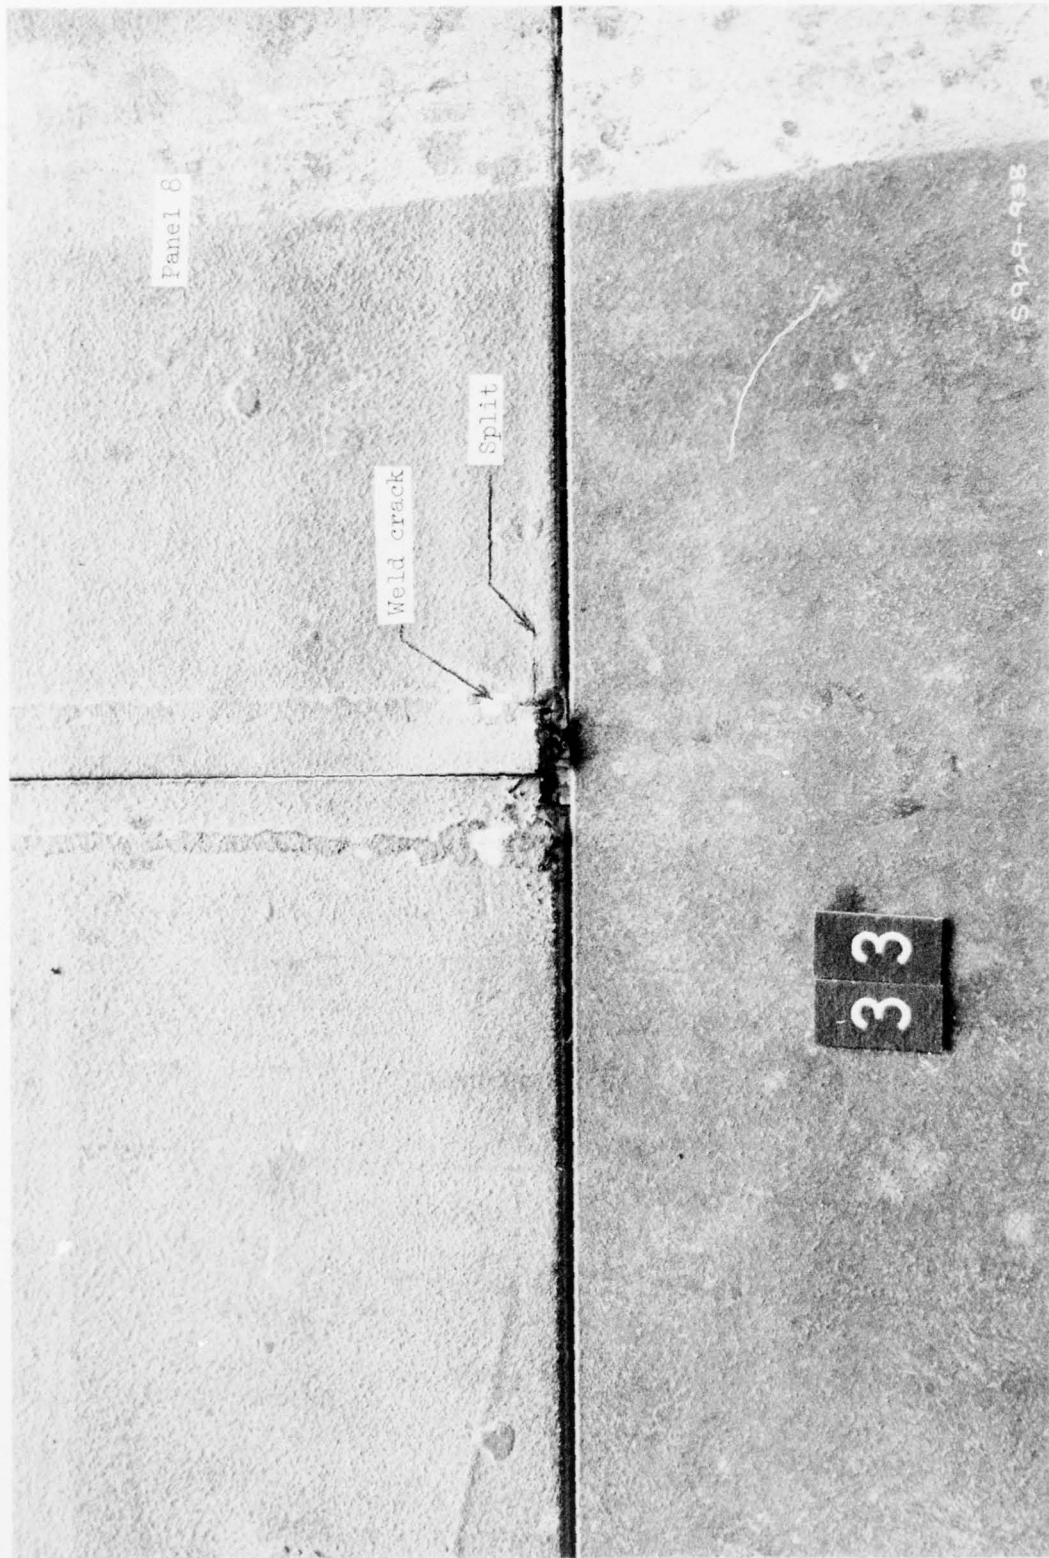
Crack in weld between I-lock and extrusion and split along male connector of panel 8 after 832 coverages, Phase 2

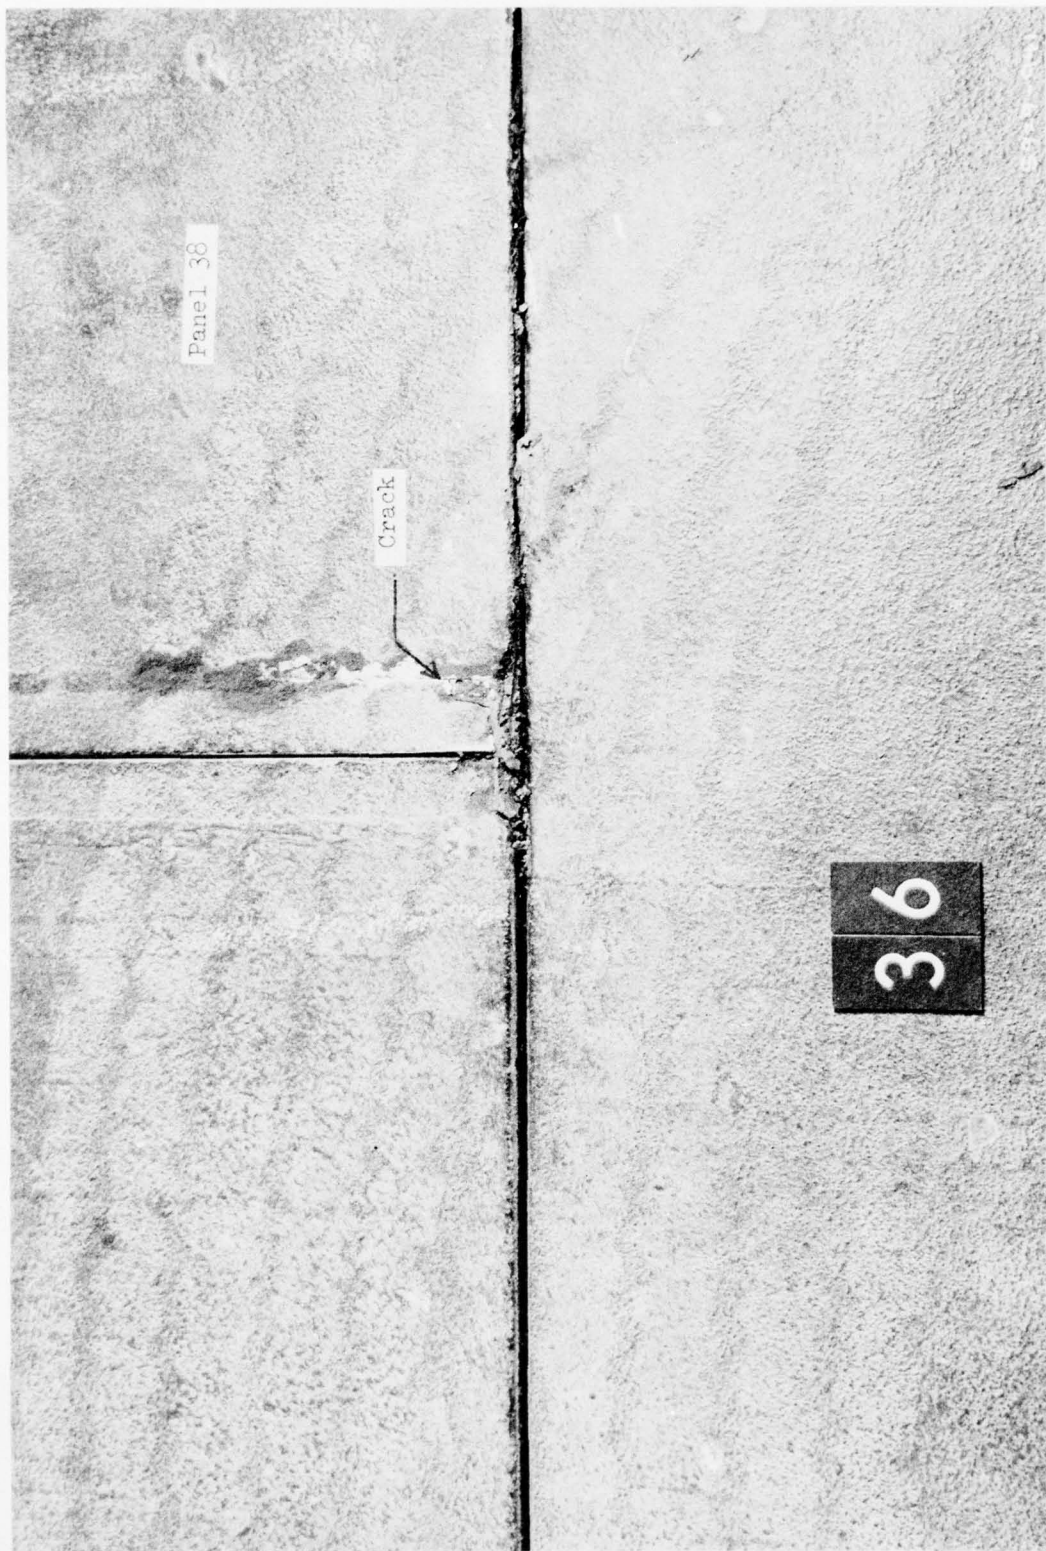
Crack in weld between I-lock connector and extrusion of panel 38 after 832 coverages, Phase 2

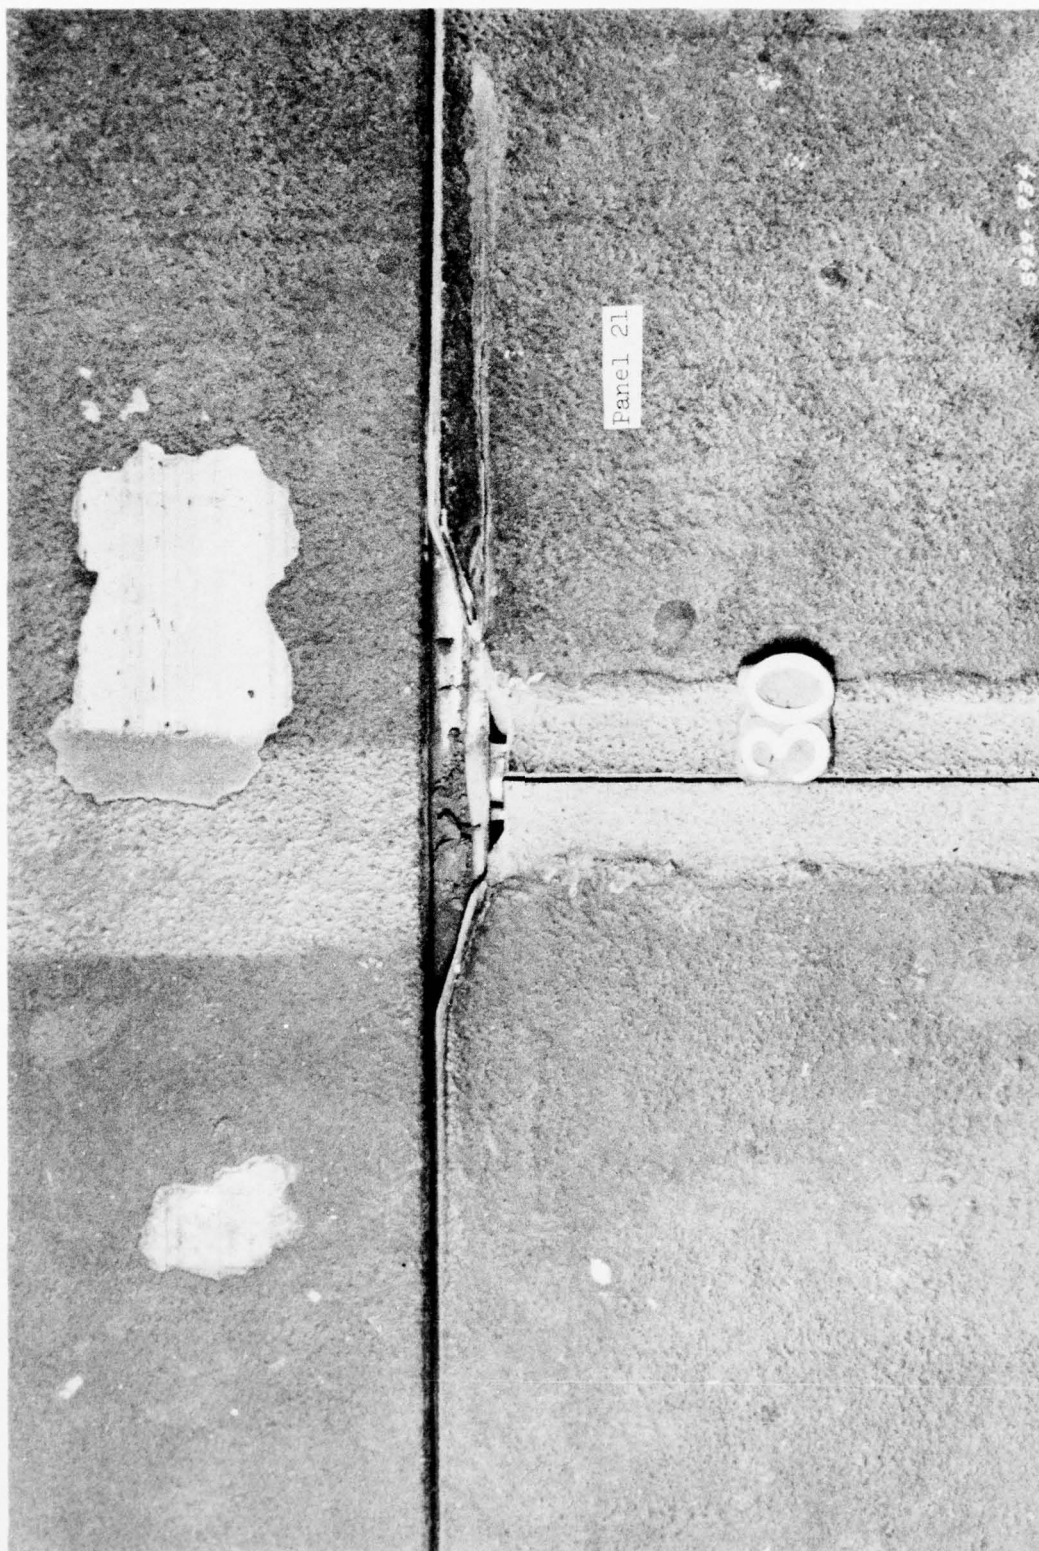
Split in the female connector of panel 21
